Stakeholder Liaison Group

Meeting 20th March 2024

Programme Update

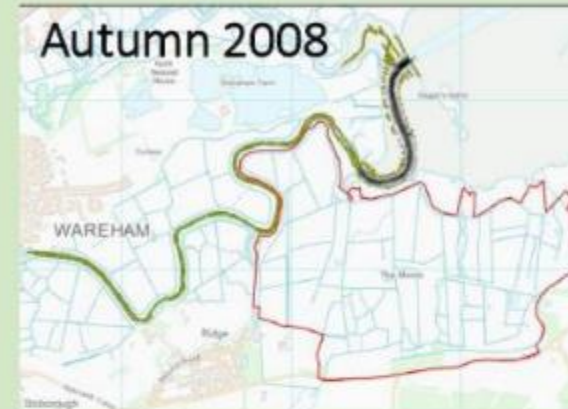
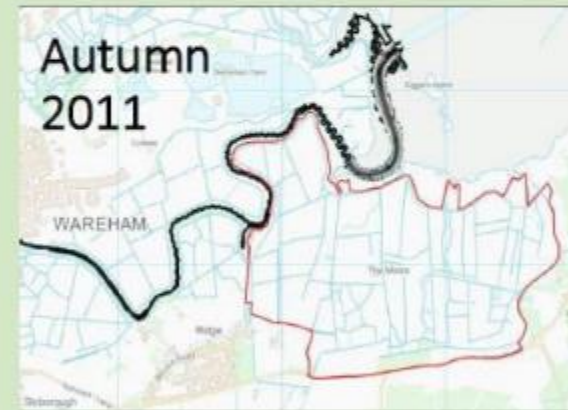
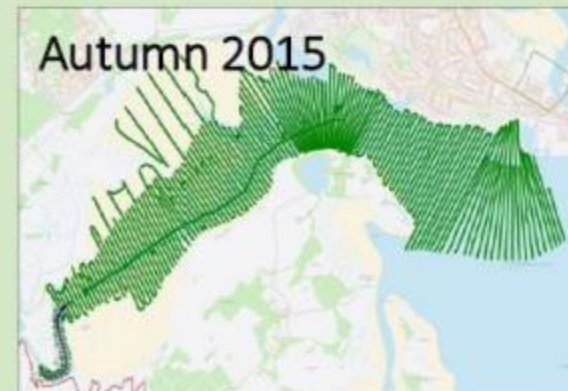
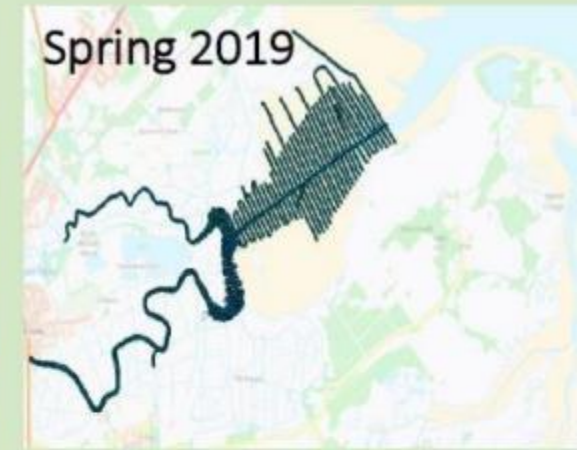
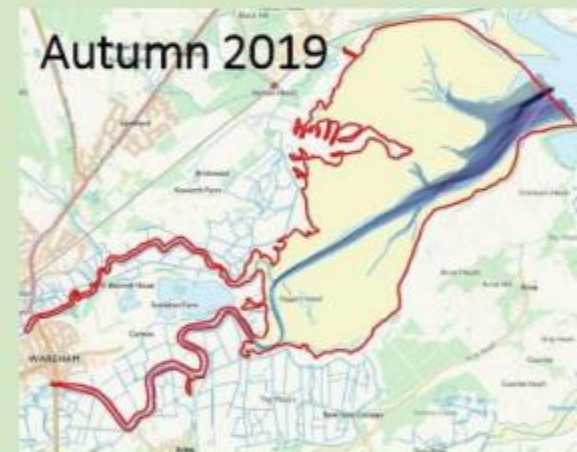
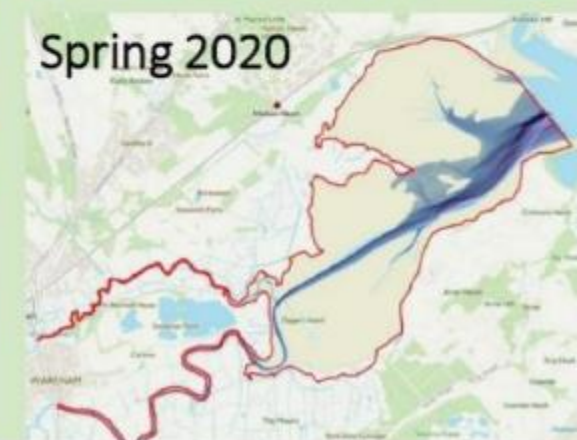
Recent and ongoing LiDAR & bathymetry summary

- 2008-2015 bathymetry surveys useful but variable coverage and detail.
- Spring 2019 to spring 2020 bathymetry surveys consistent in coverage and detail, developing a good baseline dataset.
- 2013 and 2020 LiDAR with consistent 1m resolution

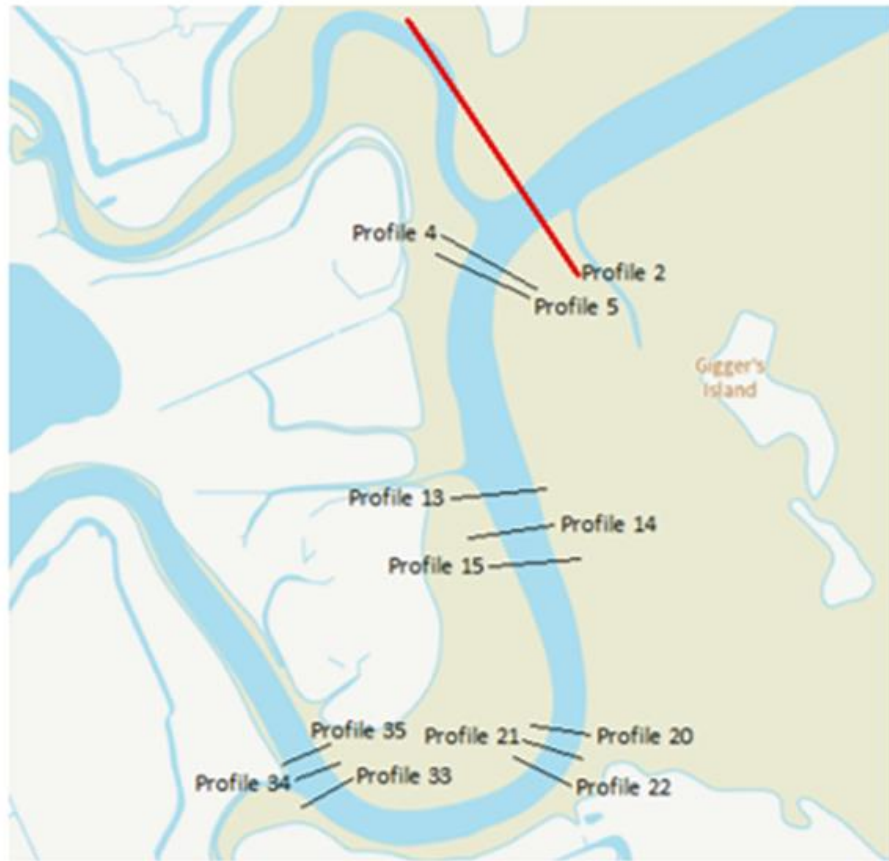
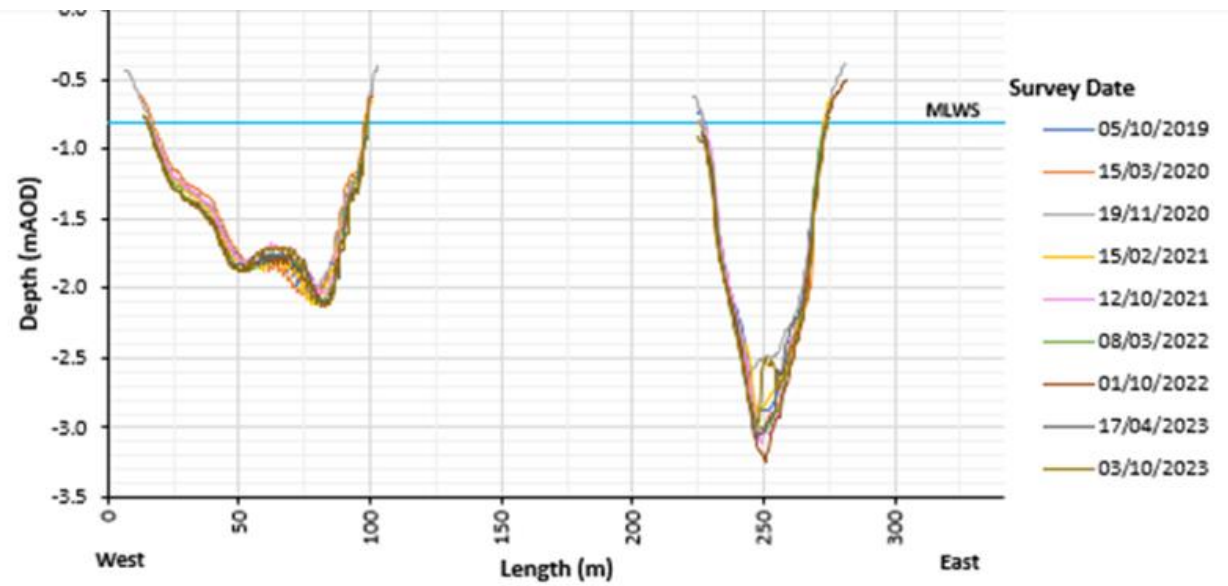
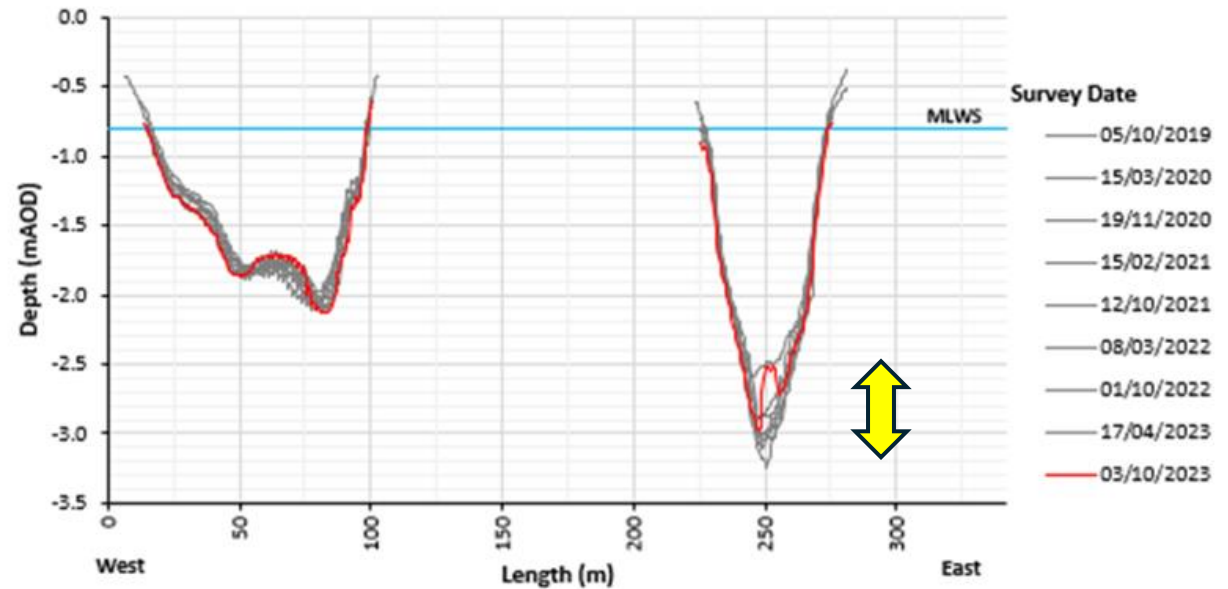
Bathymetry Comparison – Profile 2

Wareham Channel cross-section locations

-3.4 to -2.5 m OD (2019-2023)

- Channel profiles (mudflats) are 95% mud & silt
- Mid channel sections comprise mixed mud/sand/gravel
 - Sand <48% Gravel <68%
 - Dominant coarse sediments are fluvial
- Profiles generally erosive between 2019-2023
 - 20-30cm banks 30-40cm bed
- General pattern of meandering to the Southern bend of the Wareham Channel

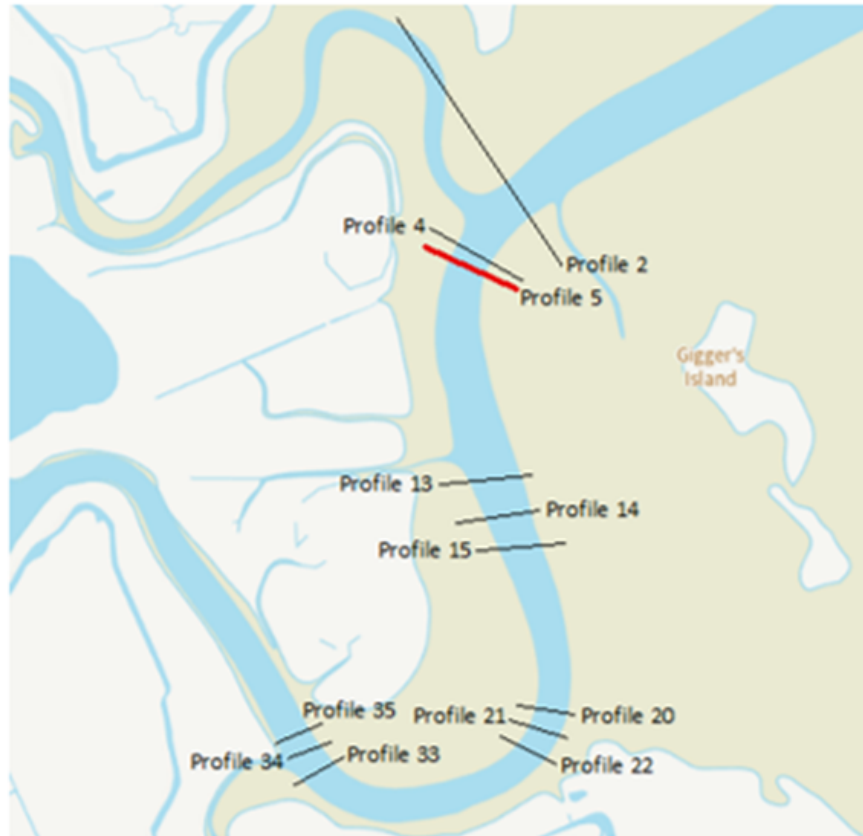
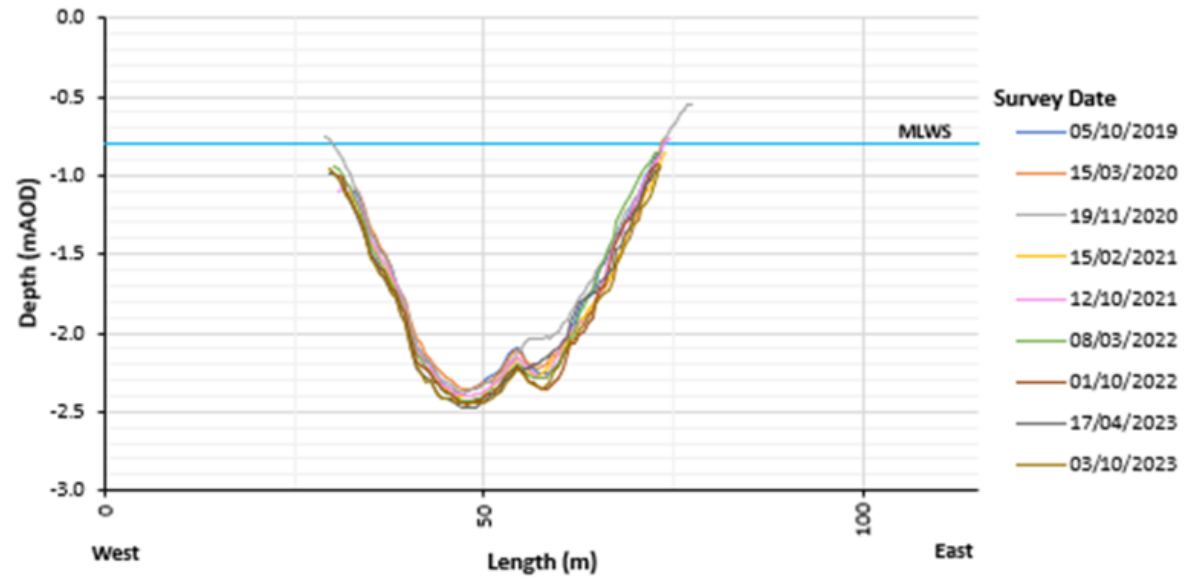
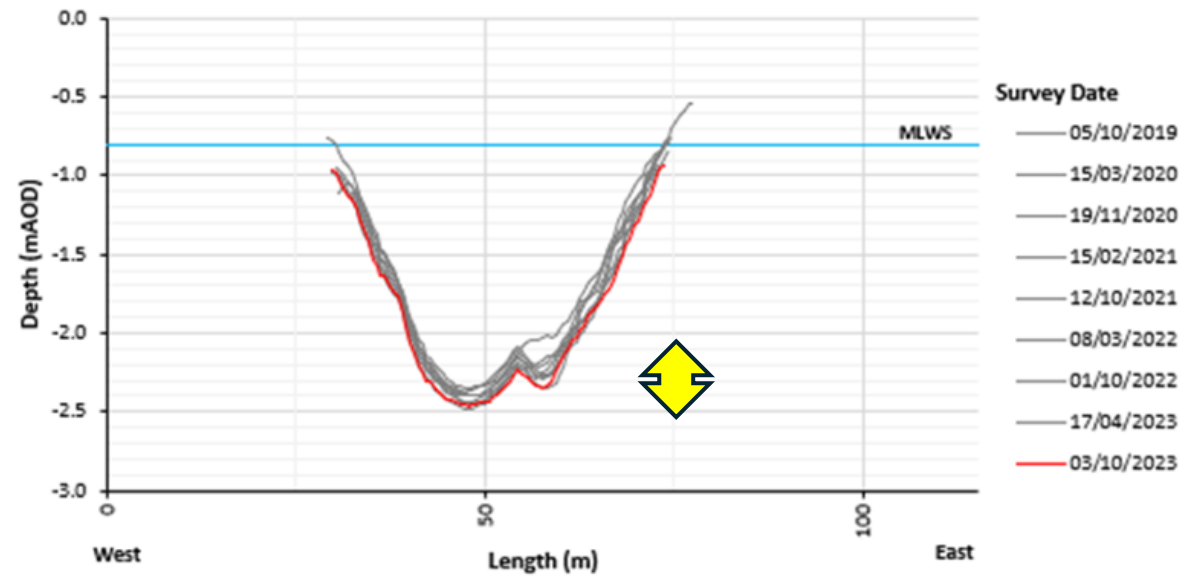
Bathymetry Comparison – Profile 5

Wareham Channel cross-section locations

Lateral erosion general deepening

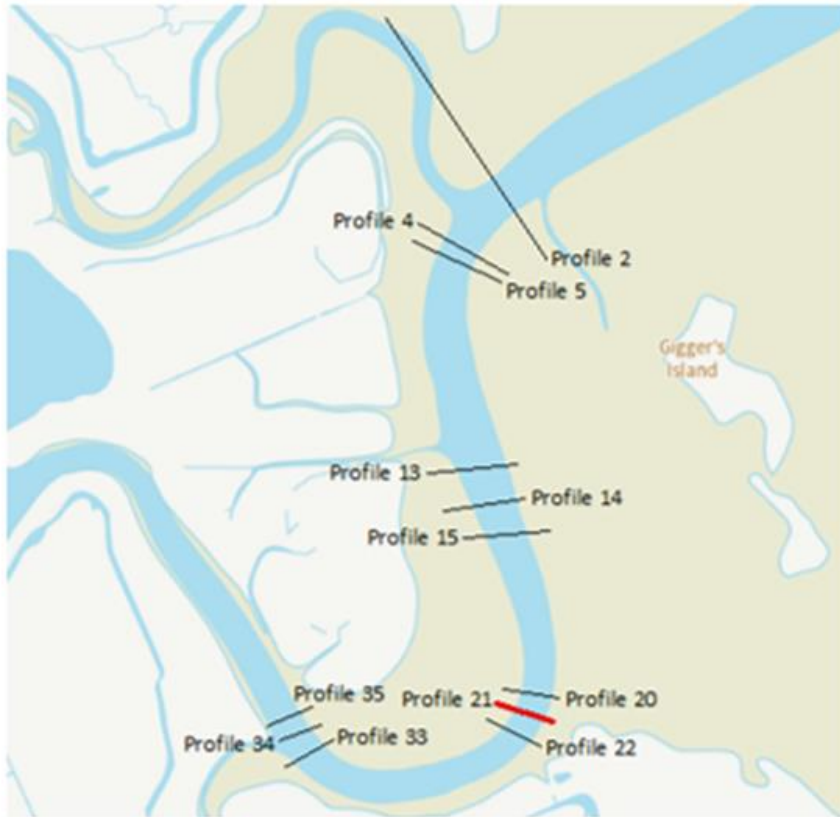
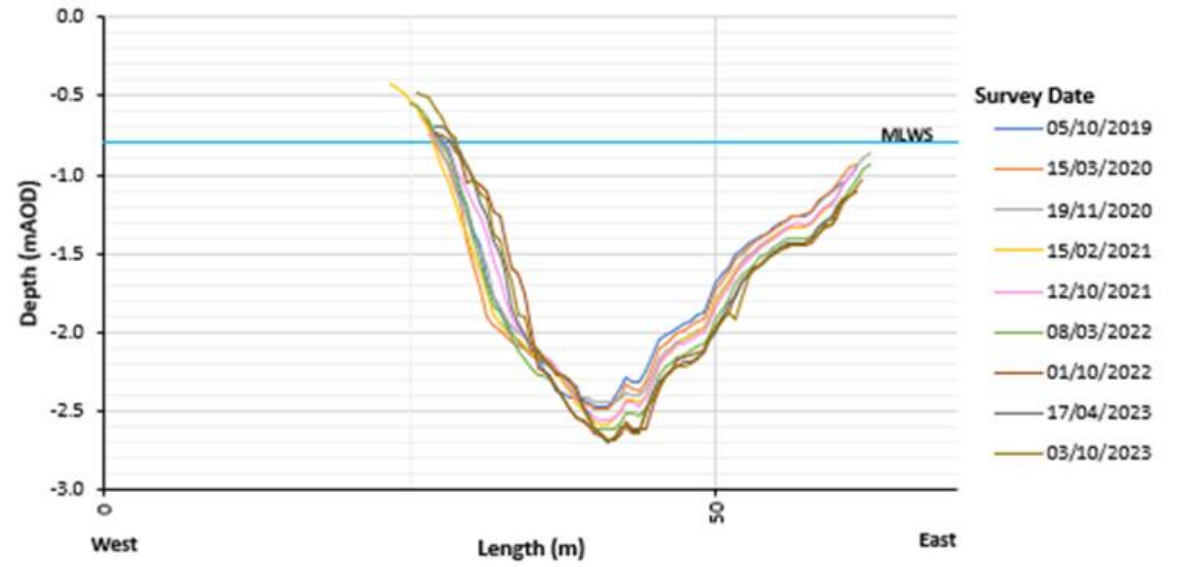
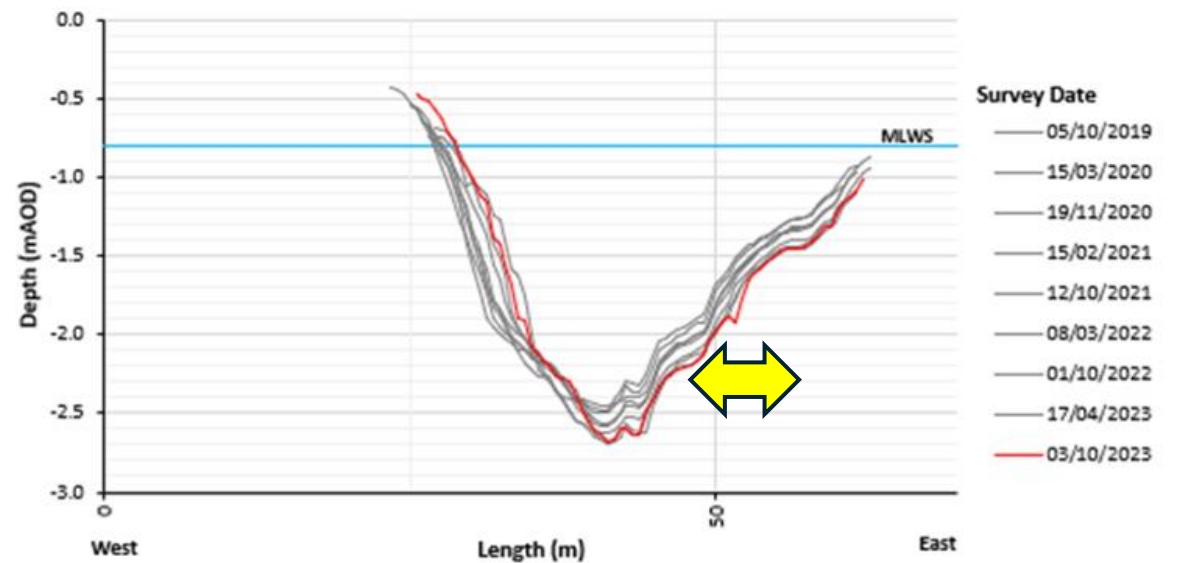
Bathymetry Comparison – Profile 21

Wareham Channel cross-section locations

Channel migration 10m West to East

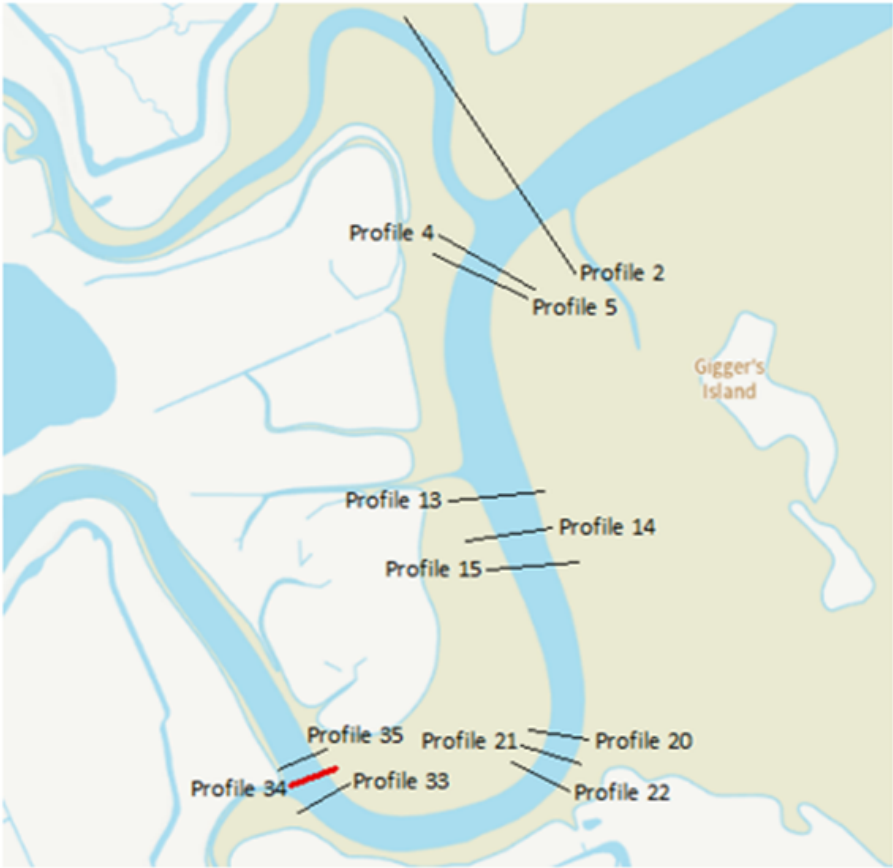
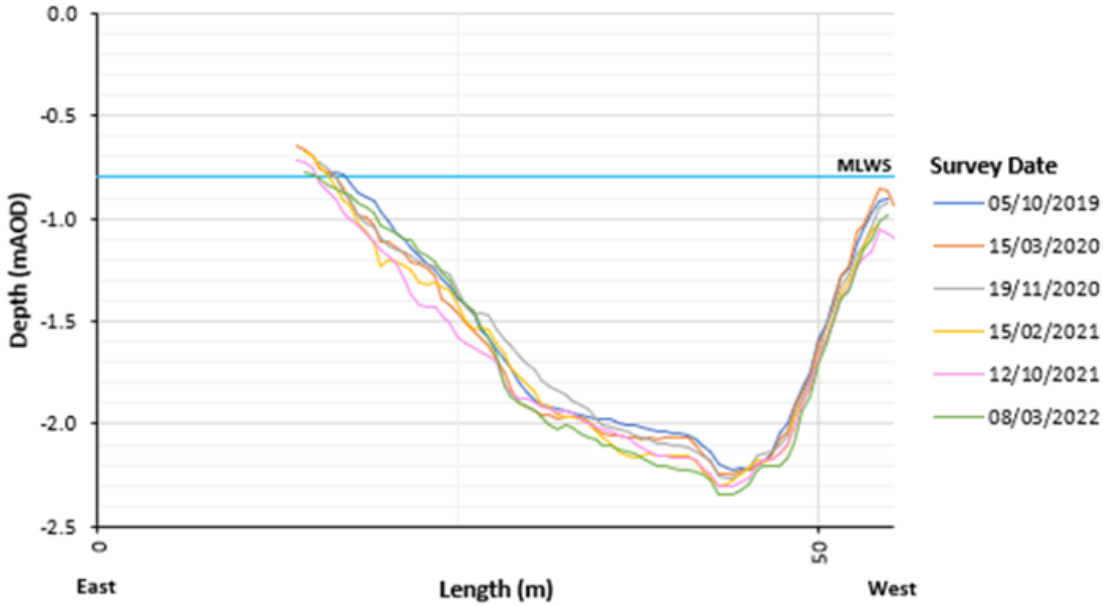
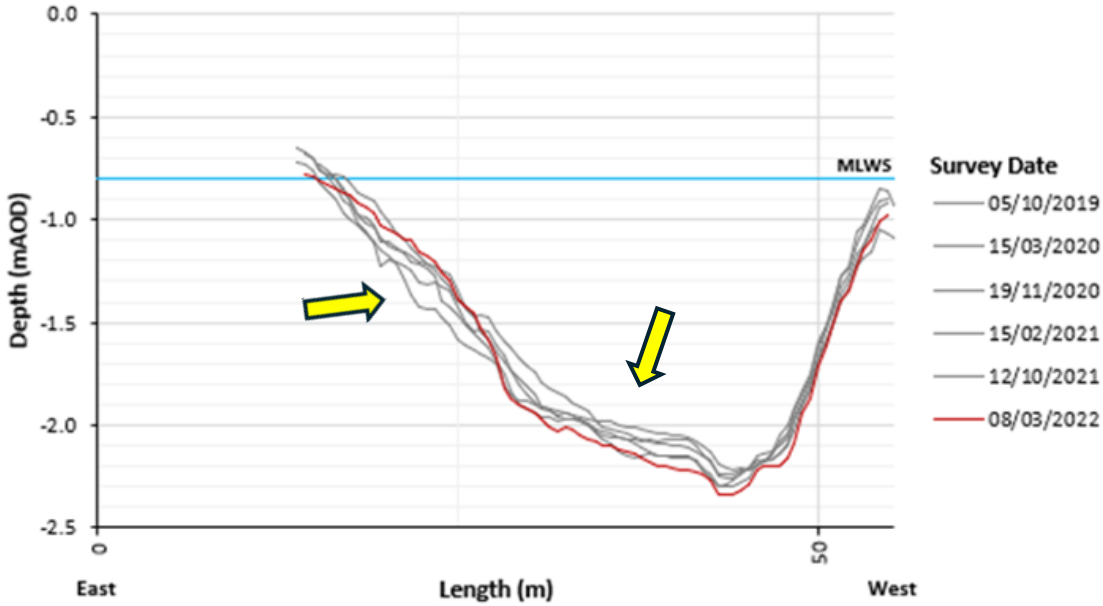
Bathymetry Comparison – Profile 34

Wareham Channel cross-section locations

General erosion of bed and deposition to East
