Kier Ltd for Environment Agency

**Arne Moors Coastal Change Project:
Characterisation of Wareham Channel Sediments**

Report No. ENV0011

March 2024

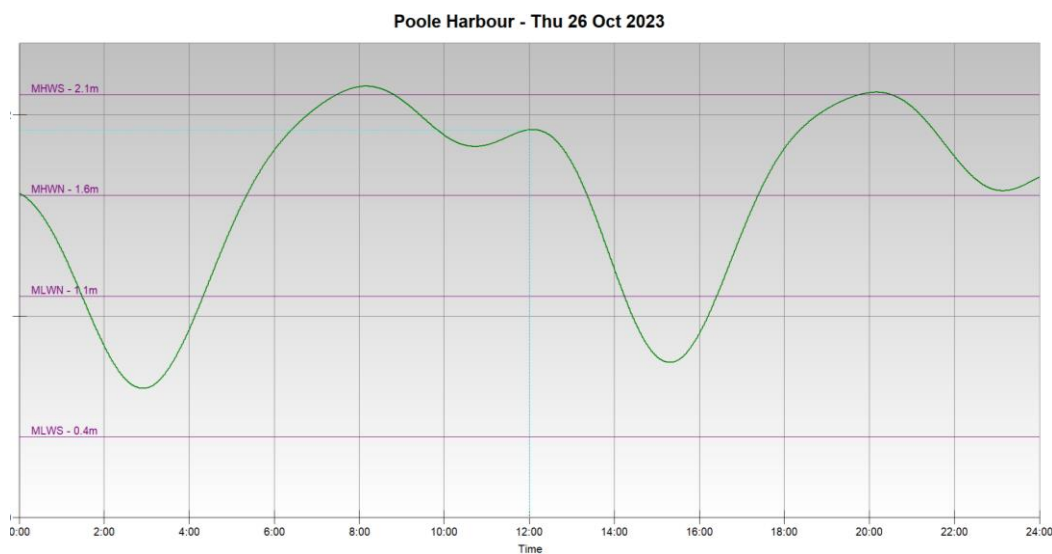
Figure 3. Poole Harbour Tides during the first survey day 26 October 2023 (from Belfield Tide Plotter Programme, 2018).

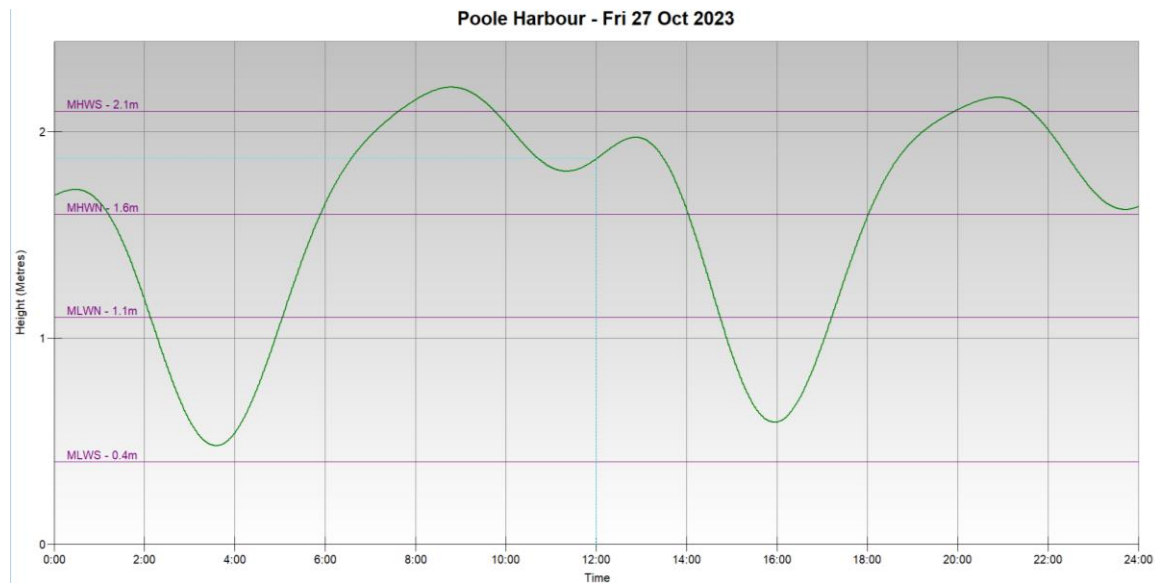
Figure 4. Poole Harbour Tides during the second survey day 27 October 2023 (from Belfield Tide Plotter Programme, 2018).

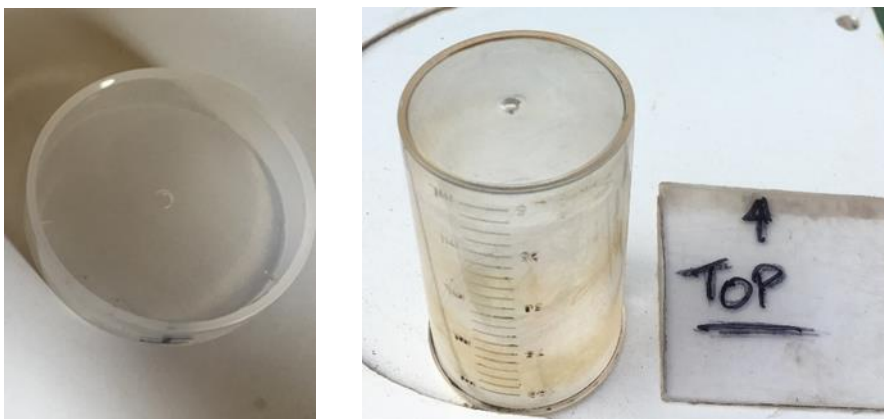
Density core samples were taken from the surface of the grab samples by driving the straight-sided bespoke beakers vertically into the sediment and using a cutting plate at the base to extract a fixed-volume sample. The beakers with samples were placed into pre-weighed bags and stored in a cool box prior to weighing in the laboratory. 1cm and 7cm density beakers are shown in Figure 7.

Figure 7. 1cm and 7cm density beakers and cutting plate.

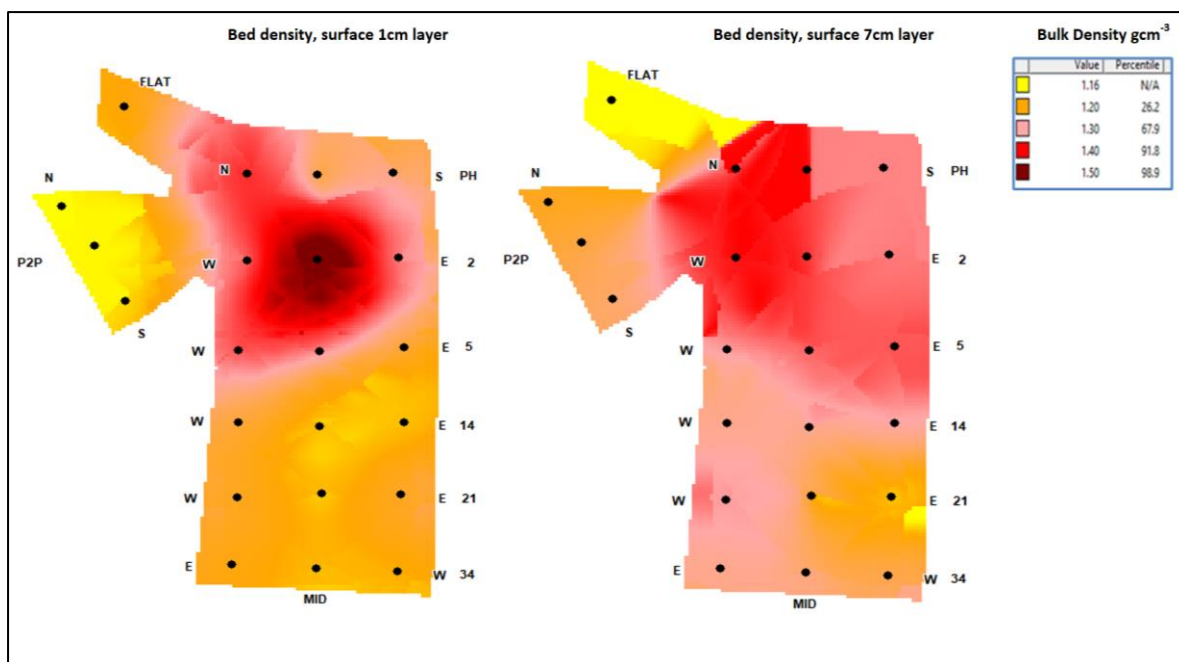
Figures 9a and 9b. GIS spatial image of the distribution of sediment density from 1cm and 7cm cores.

The density data show a variation in density of the top 1cm between 1.16 and 1.87gcm⁻³. The highest values, 1.87gcm⁻³, were found at site P2F-MID, in the mid channel at the confluence of the Frome and Piddle mouths where the samples contained a lot of sand, that increased the density and compaction. Figure 10 shows the density vs sand content for the top 1cm layer, showing a density variation between 1.15 to 1.30 gcm⁻³ for 0-10% sand, reflecting different degrees of consolidation. The lowest 1cm surface densities (around 1.16gcm⁻³) were found within the outer Piddle estuary, with high mud content and low sand content and of soft, underconsolidated consistency indicating recent deposition. Generally, the surface 1cm densities were lower at the edges of the channels and mudflat areas, reflecting depositional environments where fine sediments dropout during high tide, low flow periods and slowly consolidate.

Table 2 shows the density values for each site and Figures 9a and 9b show the density variation plotted schematically in GIS.

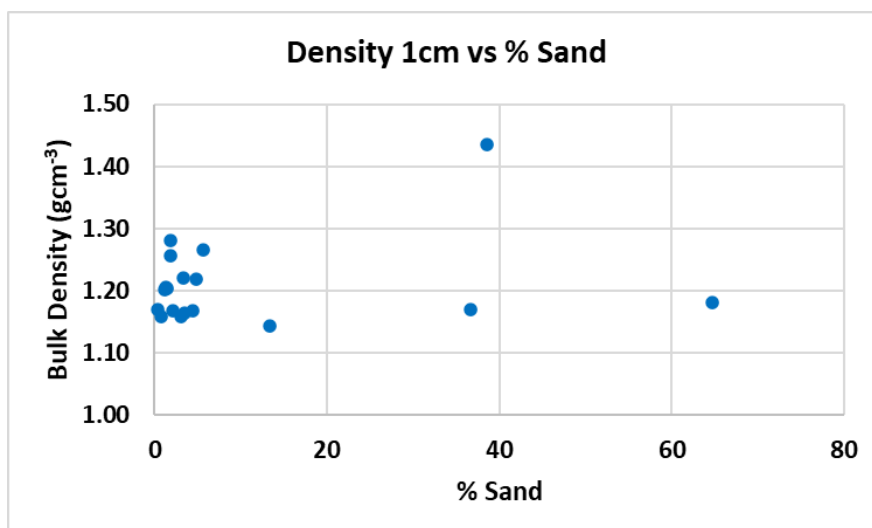
Figure 10. Density of top 1cm vs %Sand content.

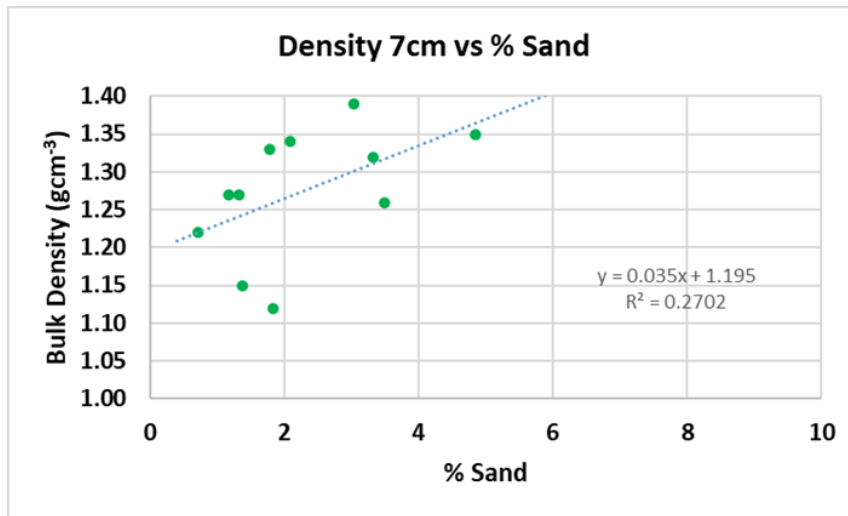
Figure 11 shows the density vs sand content for the top 7cm layer, showing a positive relationship, as found in literature (Whitehouse *et al.*, 2000). The 7cm densities ranged from 1.15 to 1.39gcm⁻³,

with the highest values around the confluence of the Frome and Piddle mouths and Profile 5. The lowest 7cm density layer values were found on the mudflat proper sites to the north of site PH and at the Frome banks at profiles P21 and P34, in regions of quieter flow, depositional environments with high mud contents (fines fall out) and underconsolidated sediments.

Figure 11. Density of top 7cm vs sand content.

The 'bulk' 7cm densities showed a positive relationship with sand content, in agreement with that found in literature (Whitehouse *et al.*, 2000), related to greater grain size and compaction. The highest values were found at the confluence of the Rivers Frome and Piddle and shoal region where flows and bed shear stresses are greatest and the bed is undergoing periods of erosion and tidal sediment recycling, either as bedload (medium sand) or suspended load (fine sand). The bank and mudflat sediments had the lowest densities consistent with finer underconsolidated muddy sediments.

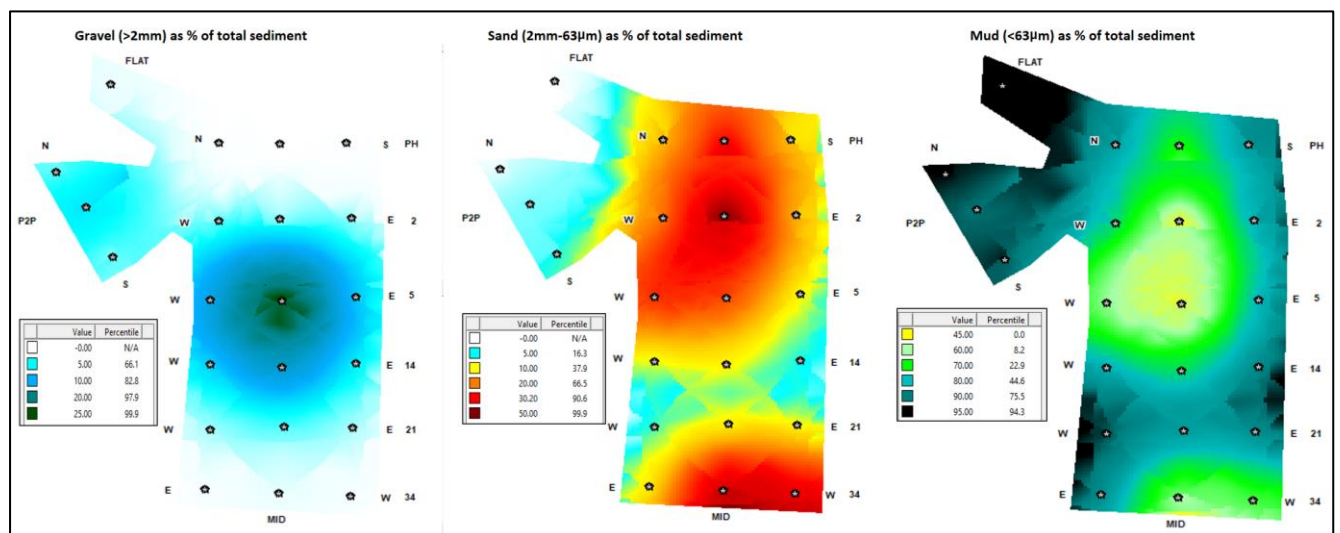
Figure 12a, 12b and 12c. Relative contributions of gravel, sand and mud in the sediment samples.

Gravel amounts varied between near-zero to a maximum of 48% at P5-MID on a known shoal in the mid channel. Highest gravel contents were found in the mid channel towards the north in mid-stream (P5-MID and P14-MID) where flows and bed shear stresses are likely to be the greatest during extreme weather events with high river flows, wave induced currents and high Spring and Autumn Equinox Spring tides. The lowest % gravel was found in the outer region in Poole Harbour

Sand content varied between 0.4% and 64%. The highest sand content was generally found in mid-channel regions, particularly at the Piddle estuary mouth and the west of Turner’s Cove (profile 34), where it is likely to have been deposited load from suspension or as local bedload. The lowest sand contents generally occurred in the lower Piddle estuary (P2P), mudflat site (PH-FLAT) and towards the bank regions.

Table 2 shows the percentages of gravel (>2mm), sand (63µm to 2mm) and mud (<63µm) for the bulk samples taken from the top ~10cm of the bed. Figures 12a, 12b and 12c show the GIS images of the distributions of these fractions.

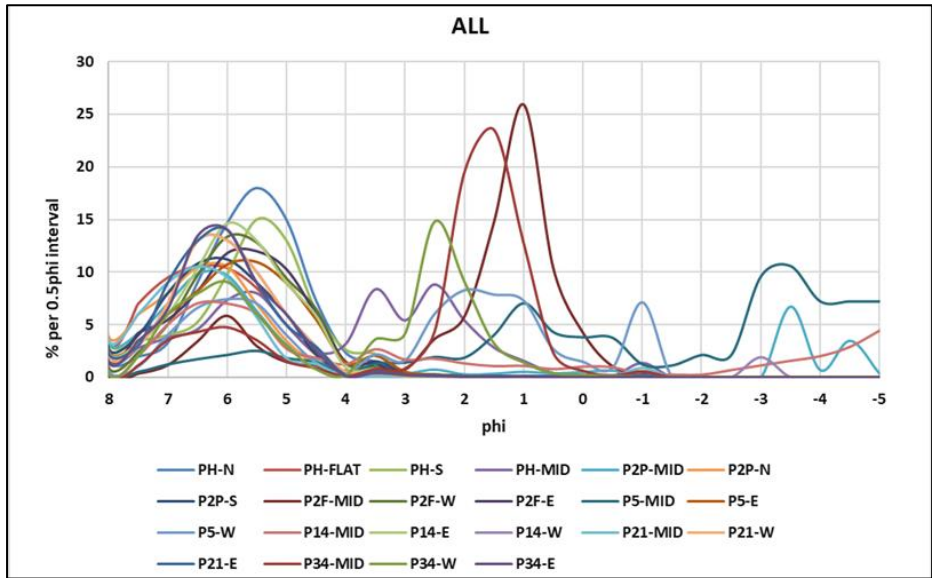
Figure 13 shows the distribution of all of the size fractions between -5 and 8 phi (4µm to 3cm) for all of the sites, as discrete distributions, thus highlighting the particle populations present. The majority of the sites were predominantly mud (95% or higher) and this is reflected in the generally higher % contributions from the silt and fine sand fractions (0 to 8 phi).

Figure 13. Distribution of all the fractions within the samples from 8 to -5 phi (4µm to 3cm).

For the banks, mudflat and Piddle sites most of the size components have peaks around 5.5 to 6.5 phi (medium and fine silt) with lower peaks around 3.5 and 1-2 phi (very fine and medium sand).

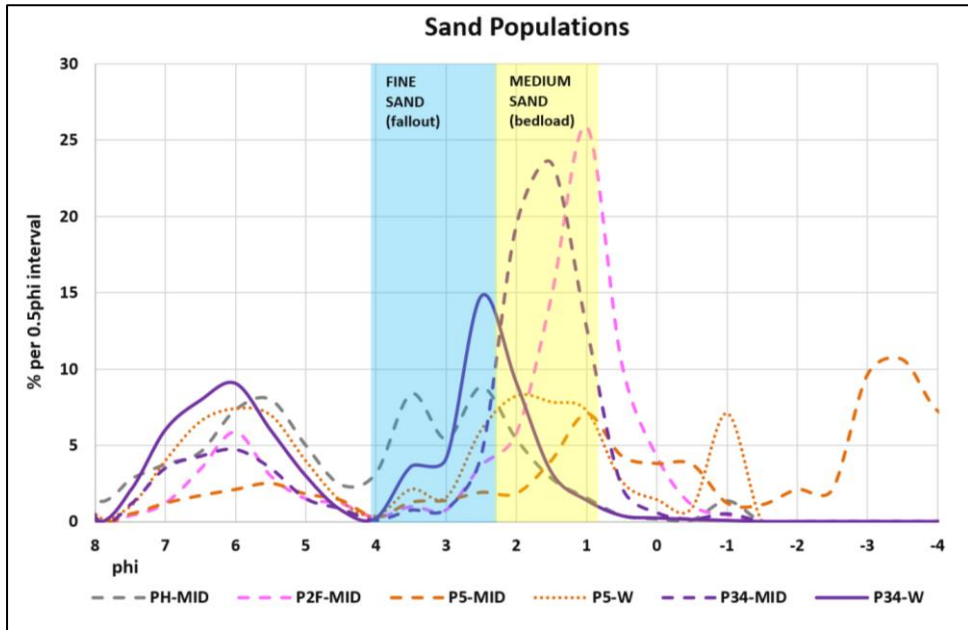
Figure 14 shows the three derived sand populations for selected mid-channel sites and at Turner’s Cove (P34) where higher sand contents are found. The most dominant peaks are for medium sand (highlighted in yellow) and fine sand (highlighted in blue). There is a lower peak around 6 phi (medium silt). These populations indicate deposition of medium and fine sand and silt fallout. medium sand likely carried as bedload in higher flow zones.

Figure 14. Sand populations for some mid channel sites and Turner’s Cove (P34).

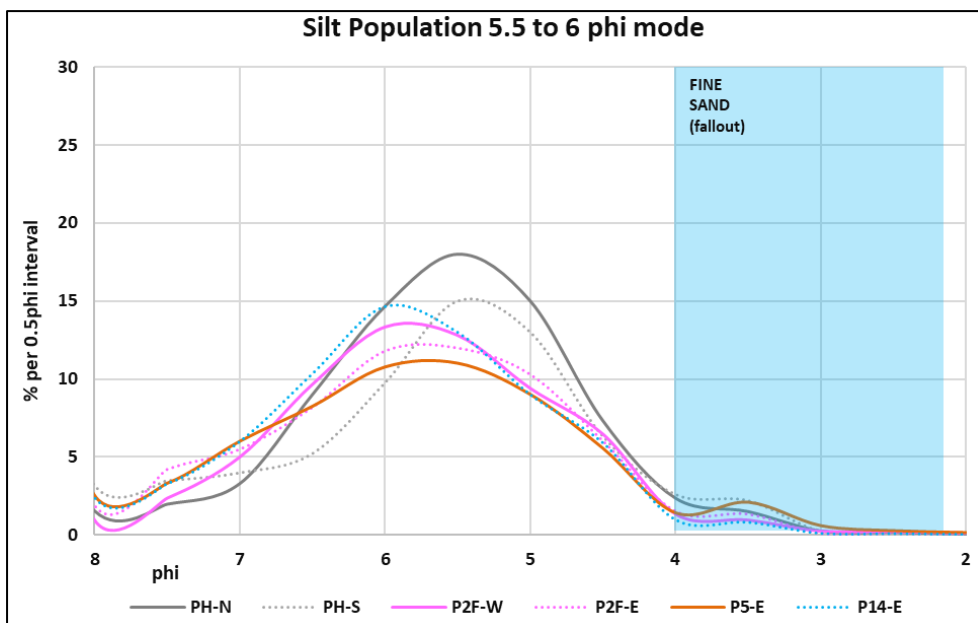
Both plots have small peaks around 3.5 phi (very fine sand) representing fine sand fallout deposits. Finer silt populations (5.5 to 6 phi), shown in Figure 15 were found at the Piddle estuary mouth (P2F), mainstream channel regions (P14 and P21), mudflat to the north and mudflat opposite Turner’s Cove. Medium silt populations (6 to 6.5 phi) were found at the Frome estuary banks, on the banks of the Poole Harbour channel and mid-channel eastern banks (Figure 16).

Figure 16. Medium silt populations at 6 to 6.5 phi for selected muddy bank sites.

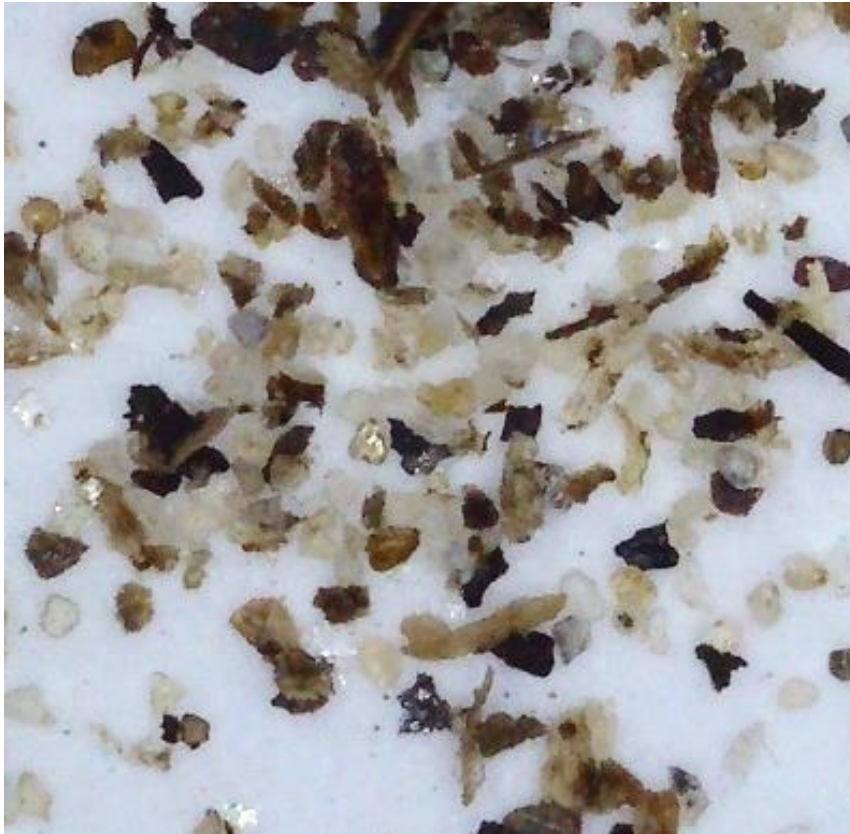
Figure 19. Close up of sediment grains retained on the 90µm sieve at site PH-S.

Photographs of the sand fractions and microscope images of the dominant fractions provided further information on the sedimentary environment. Figures 18 and 19 show the sand fraction 'wheel' photos for lower estuary bank sites PH-S and a close-up of the 90µm fraction.

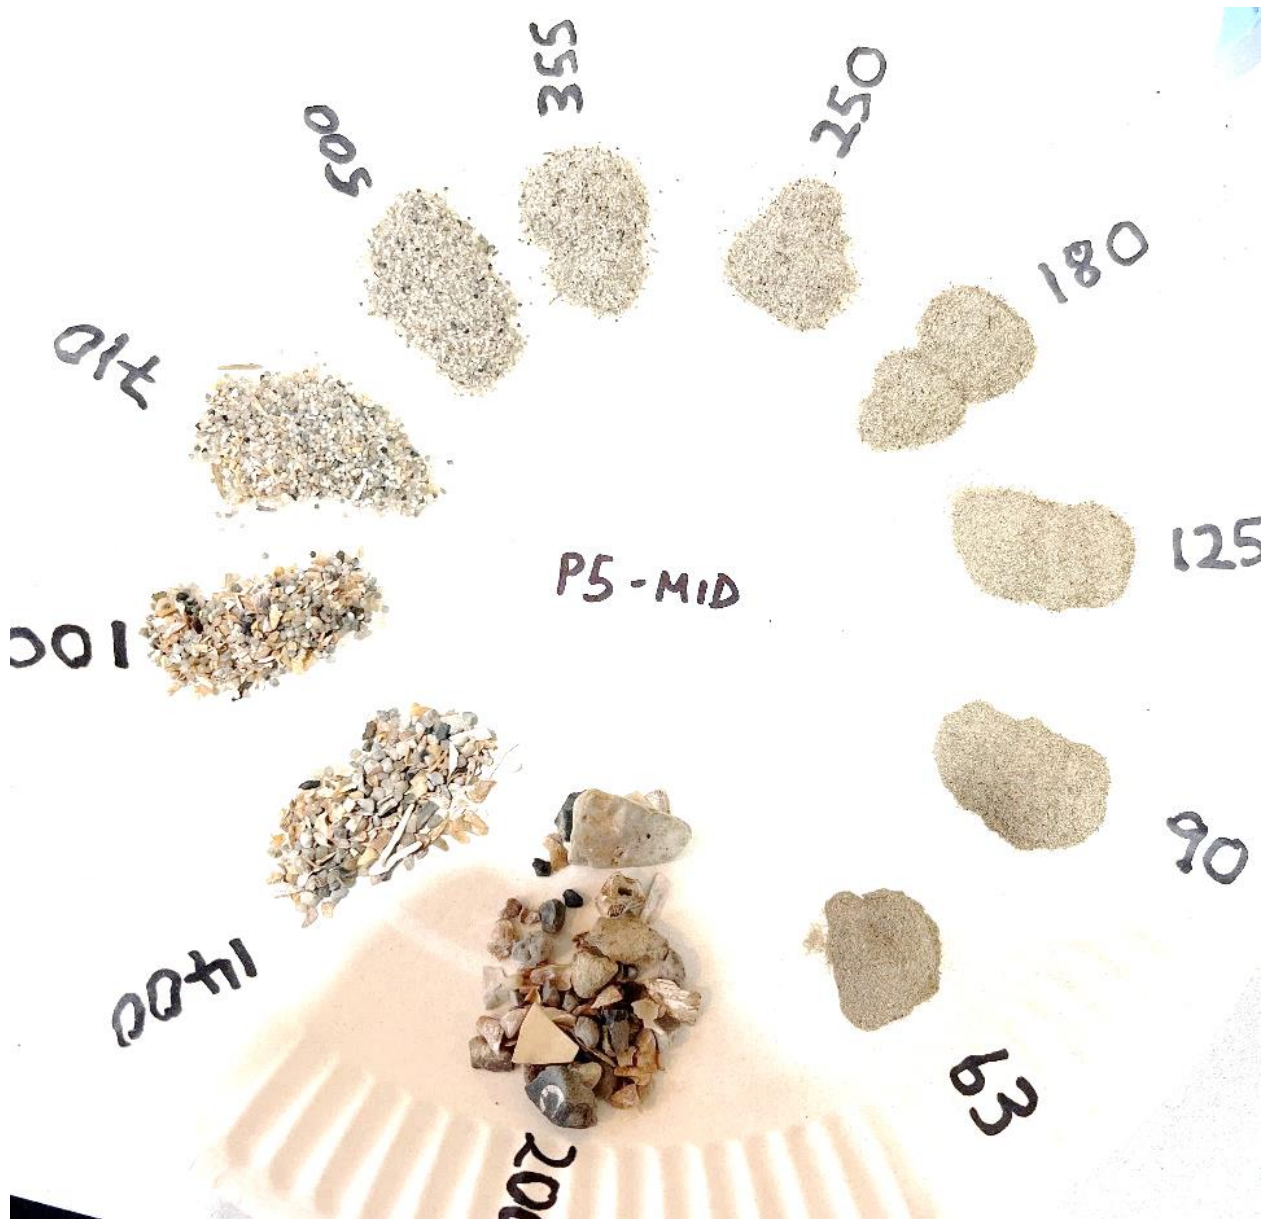
Figure 20. Grain size fractions $>63\mu\text{m}$ for site P5-MID, on the shoal in the mid-channel central region.

The size wheel for the mid-channel shoal at P5-MID (Figures 20) shows generally lighter coloured fine/med/coarse sand grains, predominantly of shell and quartz sand from erosion of Frome and Piddle chalk valleys and Poole Harbour shells. Figure 21 shows a close-up of the 90µm fraction of mixed composition. There are angular broken shell fragments from Poole Harbour, greyer more translucent quartz grains and oyster shell fragments (with shiny nacre). For the 500µm fraction, there is an approximately 1:1 mixture of shell and quartz indicating a mixture of shells derived from Poole Harbour and riverine input quartz material.

Figures 20 and 21 show the sand fraction 'wheel' photos for the mid channel shoal sites, P5-MID and close up of the $500\mu\text{m}$ fraction. Figure 22 shows a close-up of the $>2\text{mm}$ fraction.

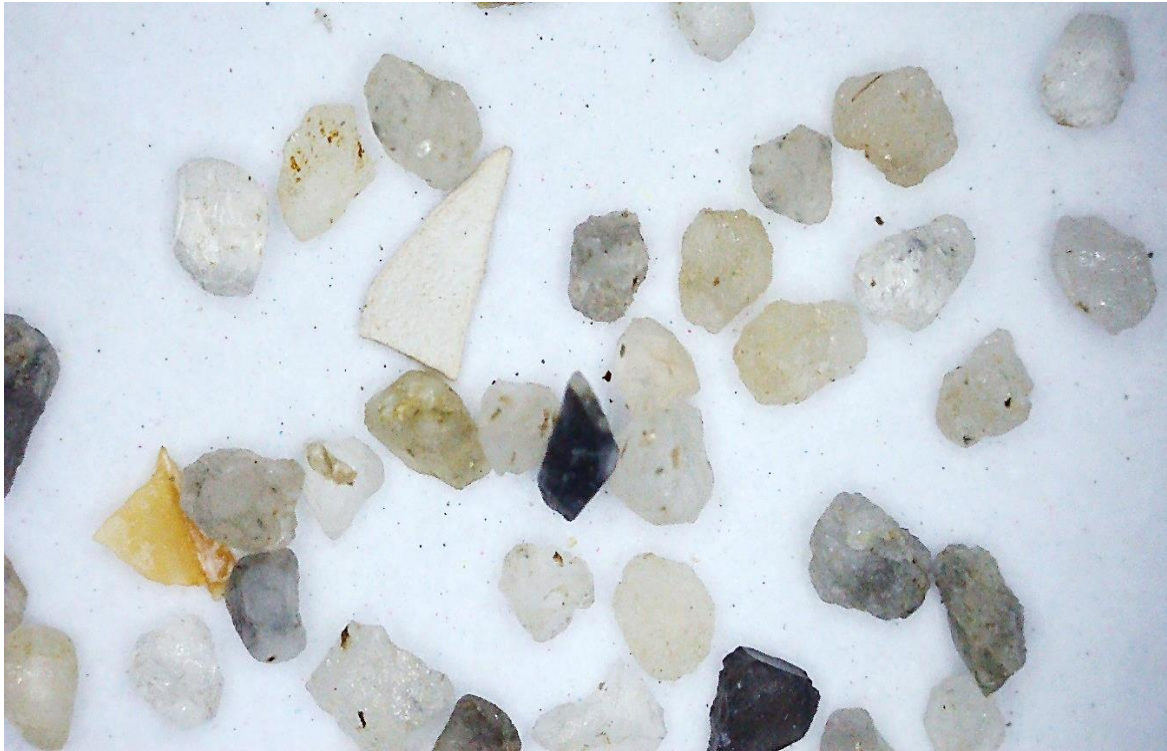
Figure 21. Close up of sediment grains retained on the 500µm sieve at site P5-MID.

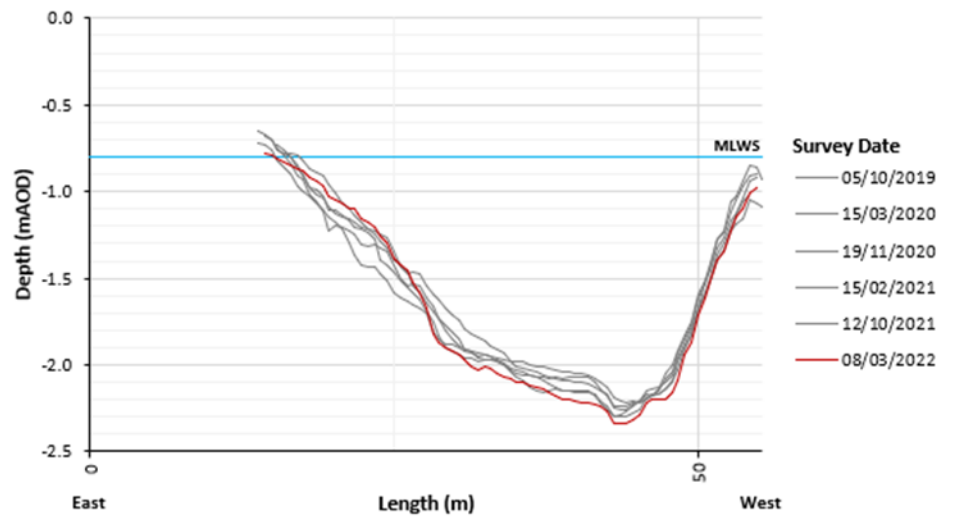
Bathymetry Comparison – Profile 34

Data is only available up to March 2022 for Profile 34. The profile is near Turner’s Cove (P34) situated further round the Frome bend west of P21. The bathymetry shows a steep sided west (outer) bank and more gradual inner east bank. The profiles show that between October 2019 and March 2022, there was gradual erosion of the lower east bank, main channel and outer west bank of around 20-30cm. The upper east bank, on the inside of the bend shows bank accretion of ~20-40cm, consistent with a depositional environment and agreeing with the muddy fine sediment found in this region and a meandering of the channel towards the west.

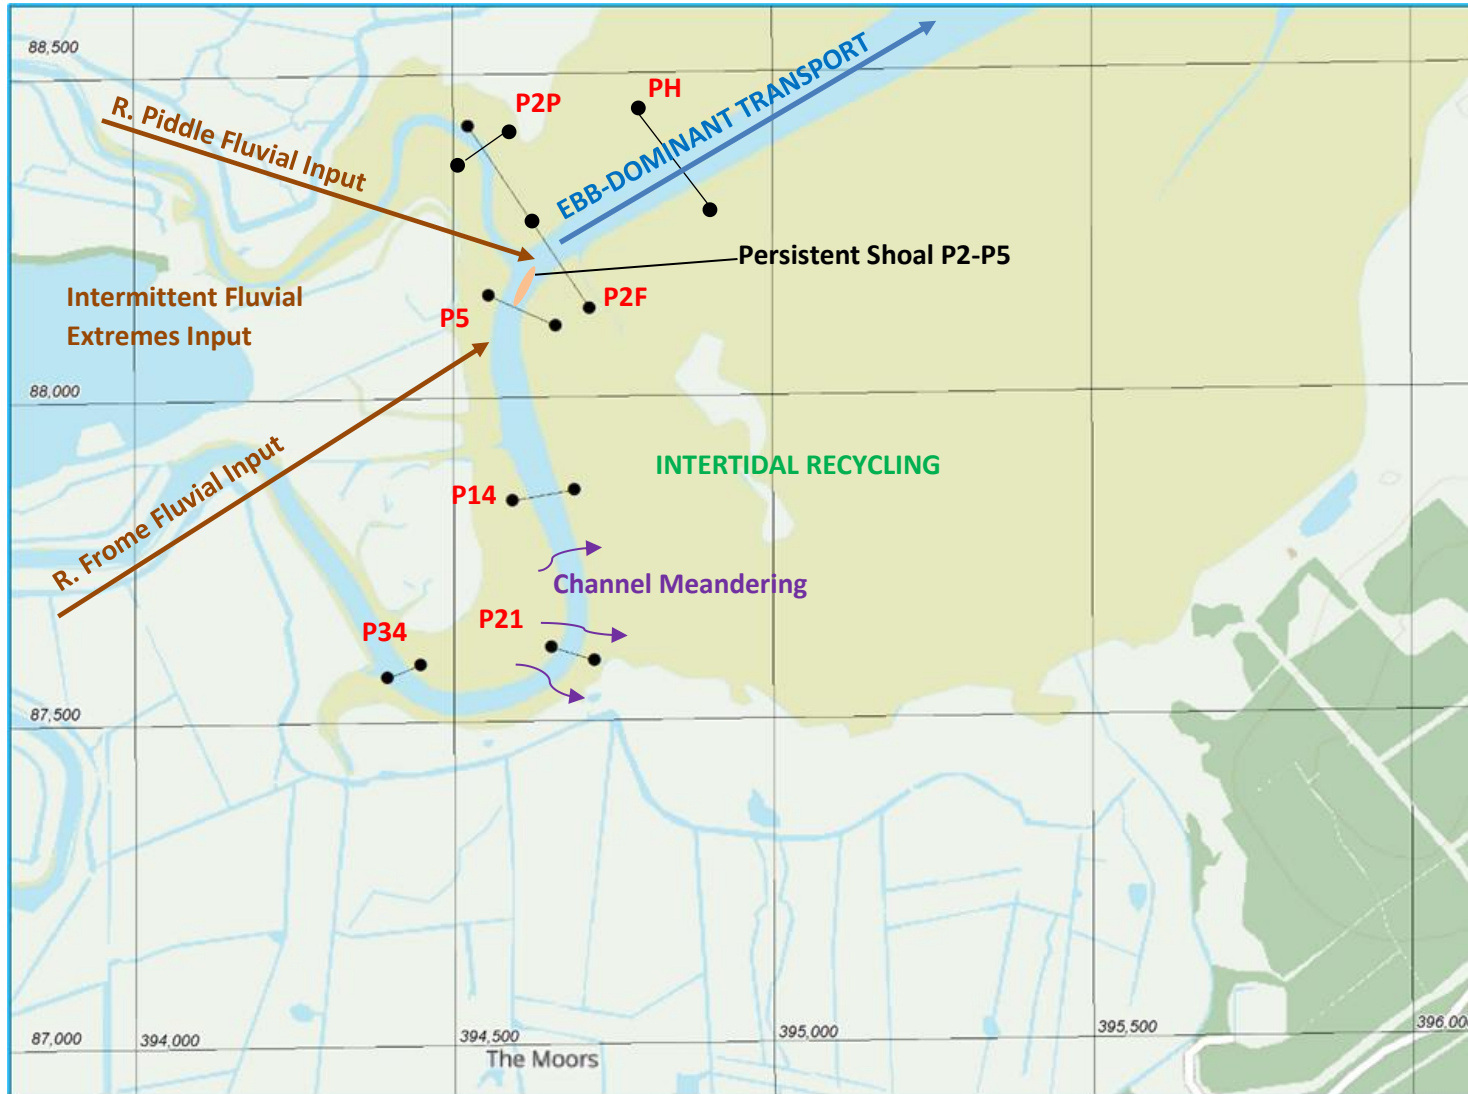
Appendix 3. Conceptual Model of the Frome and Piddle Mouths Survey Area (at October 2023)

A Conceptual Model of Poole Harbour Sediment Transport was proposed by EA/Atkins (2024). The sediment survey area covered the south western region of Poole Harbour, and the dominant local processes is shown in Appendix 2. The seabed sediment properties measured during the survey are consistent with an ebb-dominated/river flow regime as proposed. Inputs from the Rivers Frome and Piddle occur during high rainfall/high river flow conditions, mostly over late autumn-winter-early spring stormy weather periods giving an intermittent feed of fluvial sediment. Intertidal accretion is likely over time in the mudflat region around Giggers Island as a combination of tidal recycling of Poole Harbour mudflats and riverine fine sediment discharge, deposited over high water periods during high sediment load conditions. These processes are consistent with the overall Conceptual Model.
